**Flood Control Project Maintenance
Levee Inspections**

Maintenance Issue Types Only, Levee Inspection Report By Mile - Spring 2019

Reclamation District No. 2058 Pescadero

Waterway	Bank	Unit Miles	Inspection Start/End	Inspector
Unit No. 01 Paradise Cut	Left	6.58	05/06/2019 05/06/2019	Alberto De Leon

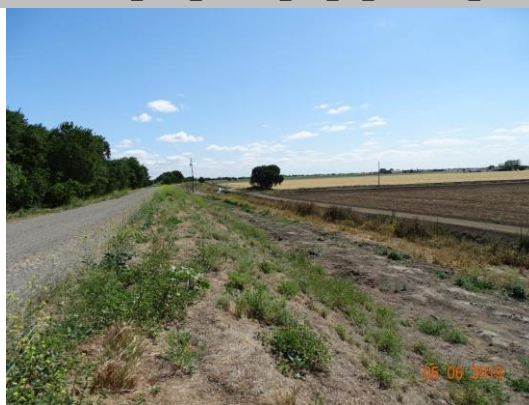
Photo 1 of 1 : SP_2019_RD2058_111_18_20190514_00055.jpg

LM Start	0.00	Rating **	M	Issue No.	18
LM End	2.41	Issue Type +	Ma	Location *	LS
Category	Earthen Levee			GPS Latitude/Longitude	
				Start	End
Item	Vegetation			37.801614 °	37.802726 °
				-121.420779 °	-121.381100 °
DWR ID	DWR_RD2058_01_s_2019_18				
Comment Code					
V1 : Control annual grass and weeds on the levee slopes and easements.					
Inspector Comment					
Annual vegetation is maintained with spray and livestock grazing.

Typical view of vegetation on landside slope. (Spring 2019)

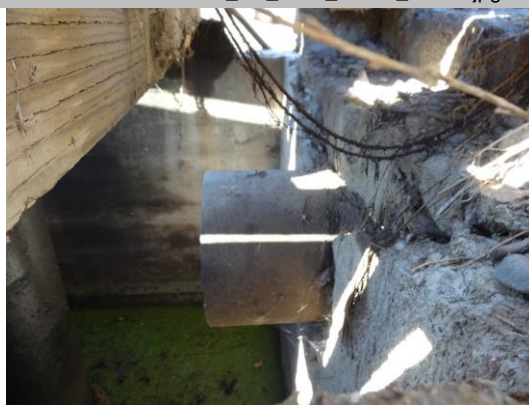
Photo 1 of 1 : UCIP_SP_2019_53531_45168.jpg

LM Start	0.72	Rating **	A/W	Issue No.	976	
LM End	0.72	Issue Type +	Ma	Location *		
Category	Supplemental			GPS Latitude/Longitude		
				Start	End	
Item	DWR UCIP LMA Responsibility			37.801792 °	37.801792 °	
				-121.410921 °	-121.410921 °	
DWR ID	22704

Comment Code						
Inspector Comment						
FS_ID:53531 DS_ID:22704 EP_NO: N/A Repair Type: No Action Needed Crossing Status: Found UCIP Comments: 12/07/2018 Need updated photos to show proper 12-inch pipe abandonment. If crossing was abandoned properly crossing will need to be removed from the LMA responsibility list. Also recommend updating photos for dsid 22700 (16-inch pipe) authorized under the same permit. (O. Magana - DWR UCIP) FIELD_STRUCT_DESC: *ABANDONED* 12-inch drainage discharge pipe of an unknown material through the levee, 18 feet below the crown. Pump on the landside (LS). Flap gate on the waterside (WS). (To abandon the existing 12-inch pipe with concrete and install a new 16-inch pipe authorized under Permit No. 5055, 1965 - Stanley Electric Motor Company). 12-inch pipe grouted in place. [Additional Reference(s): DWR Levee Log, 2005. USACE San Joaquin O&M Manual 10, March 1964, (HLM 0.72)]. FS Date: 5/12/2015

LS view: an abandoned pipe found in concrete sump.

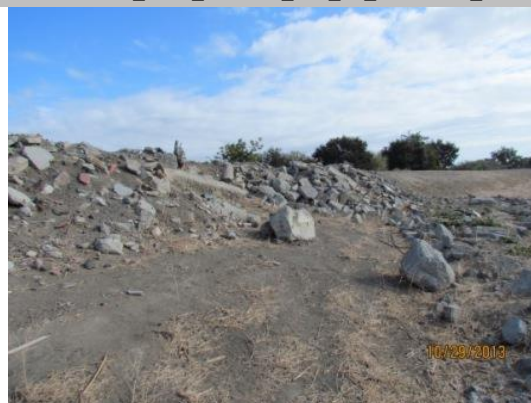
Photo 1 of 1 : SP_2019_RD2058_111_11_20190313_00005.jpg

LM Start	1.82	Rating **	U	Issue No.	11
LM End	1.83	Issue Type +	Ma	Location *	LS
Category	Earthen Levee			GPS Latitude/Longitude	
				Start	End
Item	Encroachments			37.804785 °	37.804802 °
				-121.391524 °	-121.391304 °
DWR ID	DWR_RD2058_01_f_2013_11				
Comment Code					
MA : Material					
Inspector Comment					
There is a pile of concrete which contains rebar on the landside slope obstructing visibility and access.

View of the concrete with rebar placed on the landside slope.

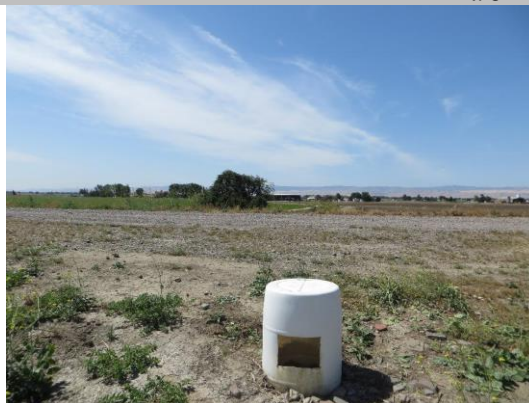
Photo 1 of 3 : UCIP_SP_2019_45865_74323.jpg

LM Start	2.12	Rating **	A/W	Issue No.	979
LM End	2.12	Issue Type +	Ma	Location *	
Category	Supplemental			GPS Latitude/Longitude	
				Start	End
Item	DWR UCIP LMA Responsibility			37.803892 °	37.803892 °
				-121.386299 °	-121.386299 °
DWR ID	22705				
Comment Code					
Inspector Comment					
FS_ID:45865 DS_ID:22705 EP_NO: N/A Repair Type: No Action Needed Crossing Status: Found UCIP Comments: FIELD_STRUCT_DESC: 20-inch steel drainage discharge pipe through the levee, 8 feet below the crown. Pump on a concrete sump in a drainage ditch on the landside (LS) toe. Siphon breaker on the waterside (WS) shoulder. [Additional Reference(s): USACE San Joaquin O&M Manual 10, March 1964, (HLM 2.14), 18-inch pipe referenced]. FS Date: 5/12/2015

Siphon breaker on WS shoulder inside protective riser.

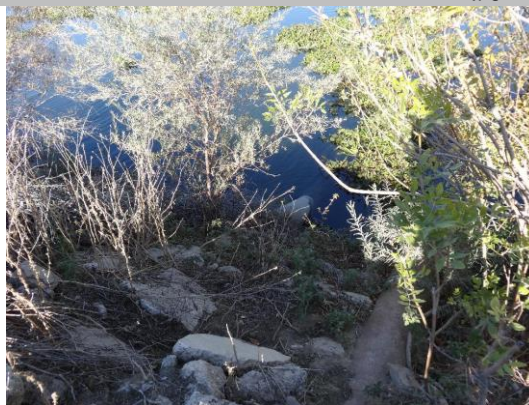
Photo 2 of 3 : UCIP_SP_2019_45865_74324.jpg

Pipe just visible at WS toe at center of photograph.

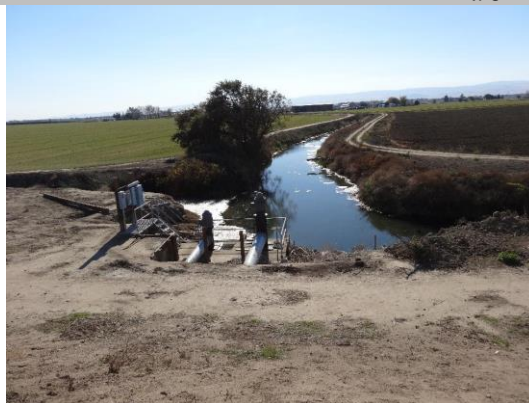
Photo 3 of 3 : UCIP_SP_2019_45865_74325.jpg

LM Start	2.12	Rating **	A/W	Issue No.	979 (cont)	
LM End	2.12	Issue Type +	Ma	Location *		
Category	Supplemental			GPS Latitude/Longitude		
				Start	End	
Item	DWR UCIP LMA Responsibility			37.803892 °	37.803892 °	
				-121.386299 °	-121.386299 °	
DWR ID	22705					
Comment Code						
Inspector Comment						
FS_ID:45865 DS_ID:22705 EP_NO: N/A Repair Type: No Action Needed Crossing Status: Found UCIP Comments: FIELD_STRUCT_DESC: 20-inch steel drainage discharge pipe through the levee, 8 feet below the crown. Pump on a concrete sump in a drainage ditch on the landside (LS) toe. Siphon breaker on the waterside (WS) shoulder. [Additional Reference(s): USACE San Joaquin O&M Manual 10, March 1964, (HLM 2.14), 18-inch pipe referenced]. FS Date: 5/12/2015

Pump on concrete pad at LS toe.

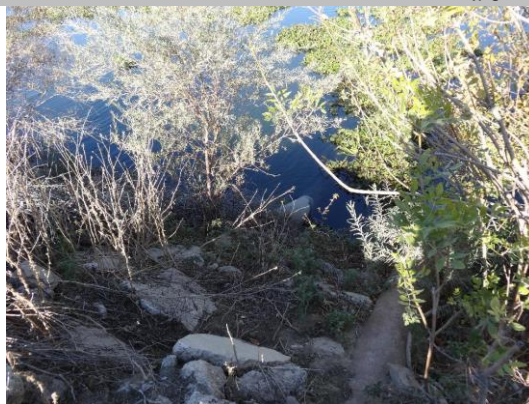
Photo 1 of 3 : UCIP_SP_2019_51699_45192.jpg

LM Start	2.12	Rating **	M	Issue No.	980
LM End	2.12	Issue Type +	Ma	Location *	
Category	Supplemental			GPS Latitude/Longitude	
				Start	End
Item	DWR UCIP LMA Responsibility			37.803886 °	37.803886 °
				-121.386271 °	-121.386271 °
DWR ID	22706				
Comment Code					
Inspector Comment					
FS_ID:51699 DS_ID:22706 EP_NO: N/A Repair Type: Non-Urgent Crossing Status: Found UCIP Comments: Leaky and damaged siphon breaker on waterside shoulder.. FIELD_STRUCT_DESC: 16-inch steel drainage discharge pipe through the levee, 8 feet below the crown. Pump on a concrete sump in a drainage ditch on the landside (LS) toe. Siphon breaker on the waterside (WS) shoulder. [Additional Reference(s): USACE San Joaquin O&M Manual 10, March 1964, (HLM 2.14), 12-inch pipe referenced]. FS Date: 5/13/2015

WS view: exposed steel pipe (right) on channel bank.

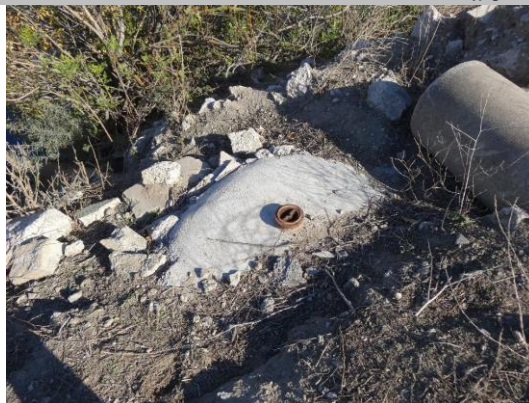
Photo 2 of 3 : UCIP_SP_2019_51699_45191.jpg

WS view: siphon breaker on concrete pad on levee slope.

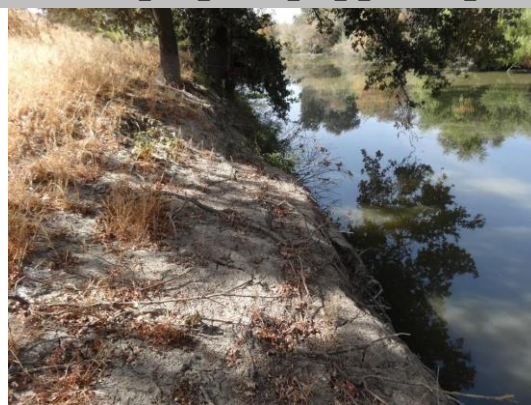
Photo 1 of 4 : SP_2019_RD2058_111_1_20190313_00001.jpg

Comment Code					
Inspector Comment					
10/10/2017: No significant change observed.					
07/20/2016: No significant change observed.					
08/04/2015: No significant change observed.					
08/26/2014: No significant change observed.					
08/28/2013: No significant change observed.					
07/26/2012: The site has been visited, and no significant change has been observed.					
09/02/2011: This site was not visited due to the time limit.					
09/22/2010: No significant change observed. Minor pocket erosions are lined at the lower bank. Two large Oak and Willow trees are on mid-slope and bench. The remaining bench was re-measured and found to be approximately 10 feet. There was no indication of active erosion on site during the site visit.					
08/05/2010: Recommended for annual assessment and monitoring of the site during flood events, per CLRO.					
07/23/2009: No major change observed since last visit; site is a 200-ft. long near-vertical berm erosion; recommend annual assessment and monitoring of the erosion site, per CLRO CES Evaluation 2008 Report; Site # is the same site previously reported as RM4.0,LM4.51; previously rated "U".

09/10/2008: Two large trees (2-3' DBH) with partial roots exposed.					
2007: Visited site 03/13/2007. [2017 Site ID:RD2058U01RM3.97]

Direct view of the pocket erosion site.

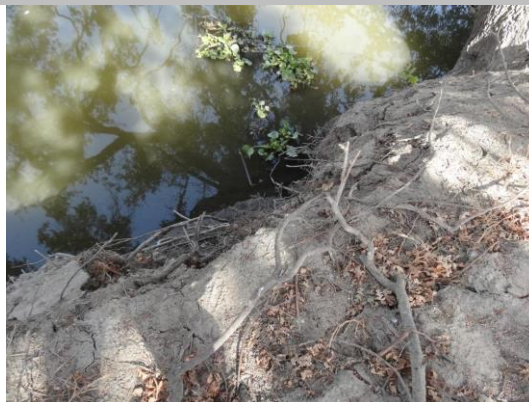
Photo 3 of 4 : SP_2019_RD2058_111_1_20190313_00003.jpg

Close view of the erosion.

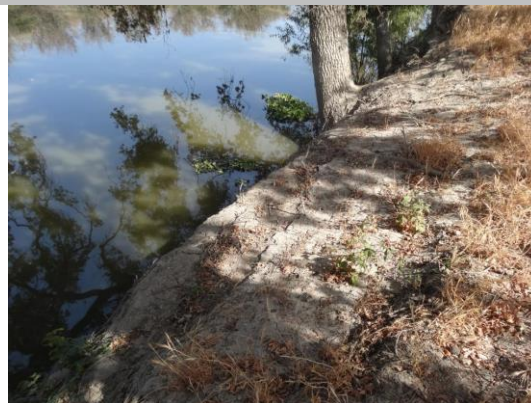
Photo 4 of 4 : SP_2019_RD2058_111_1_20190313_00004.jpg

Comment Code						
Inspector Comment						
10/10/2017: No significant change observed.						
07/20/2016: No significant change observed.						
08/04/2015: No significant change observed.						
08/26/2014: No significant change observed.						
08/28/2013: No significant change observed.						
07/26/2012: The site has been visited, and no significant change has been observed.						
09/02/2011: This site was not visited due to the time limit.						
09/22/2010: No significant change observed. Minor pocket erosions are lined at the lower bank. Two large Oak and Willow trees are on mid-slope and bench. The remaining bench was re-measured and found to be approximately 10 feet. There was no indication of active erosion on site during the site visit.						
08/05/2010: Recommended for annual assessment and monitoring of the site during flood events, per CLRO.						
07/23/2009: No major change observed since last visit; site is a 200-ft. long near-vertical berm erosion; recommend annual assessment and monitoring of the erosion site, per CLRO CES Evaluation 2008 Report; Site # is the same site previously reported as RM4.0,LM4.51; previously rated "U".

09/10/2008: Two large trees (2-3' DBH) with partial roots exposed.						
2007: Visited site 03/13/2007. [2017 Site ID:RD2058U01RM3.97]

Direct view of the erosion near a tree.

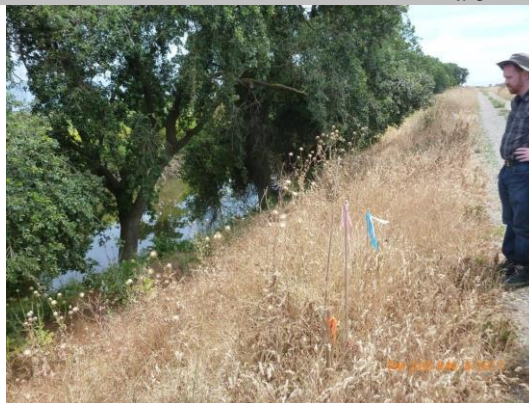
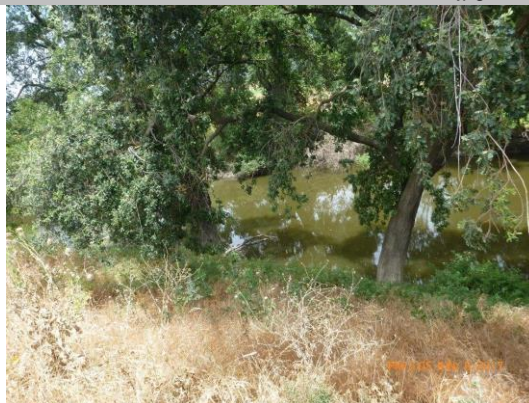
LM Start	4.63	Rating **	A/W	Issue No.	43	
LM End		Issue Type +	Ma	Location *		
Category	Supplemental			GPS Latitude/Longitude		
				Start		End
Item	2017 Storm Damage			37.787800 °		°
				-121.350860 °		°
DWR ID	DWR_RD2058_01 f _ 2017_43

Repair Type: Erosion

Notes: vegetation too dense to evaluate damage. Erosion on the waterside is greater than three feet tall into the levee prism as of Fall 2017 Inspection. Turned back over to Evaluators for re-assessment.

LM Start	4.63	Rating **	A/W	Issue No.	43 (cont)	
LM End		Issue Type +	Ma	Location *		
Category	Supplemental			GPS Latitude/Longitude		
				Start	End	
Item	2017 Storm Damage			37.787800 °		
				-121.350860 °		
DWR ID	DWR_RD2058_01_f_2017_43					
Comment Code						
Inspector Comment						
Levee Evaluation Comments						
Description:						
Site ID No:82						
Site Designation:LMA-36						
Repair Type: Erosion						
Rating:Area of Concern						
Field Date:6/8/2017						
Notes: vegetation too dense to evaluate damage. Erosion on the waterside is greater than three feet tall into the levee prism as of Fall 2017 Inspection. Turned back over to Evaluators for re-assessment.

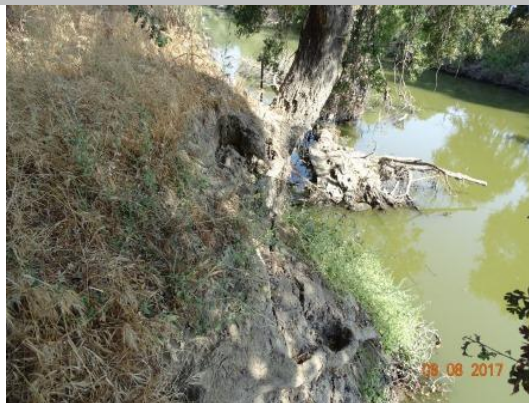
Photo 1 of 5 : SP_2019_RD2058_111_40_20190313_00020.jpg

LM Start	4.63	Rating **	A/W	Issue No.	40
LM End	4.76	Issue Type +	Ma	Location *	WS
Category	Earthen Levee			GPS Latitude/Longitude	
				Start	End
Item	Erosion / Bank Caving			37.787756 °	37.785971 °
				-121.350851 °	-121.350372 °
DWR ID	DWR_RD2058_01_f_2017_40				
Comment Code					
E2 : Schedule repair of erosion site prior to the next inspection.					
Inspector Comment					
Erosion on the waterside is greater than three feet tall into the levee prism.

Downstream view of the erosion.

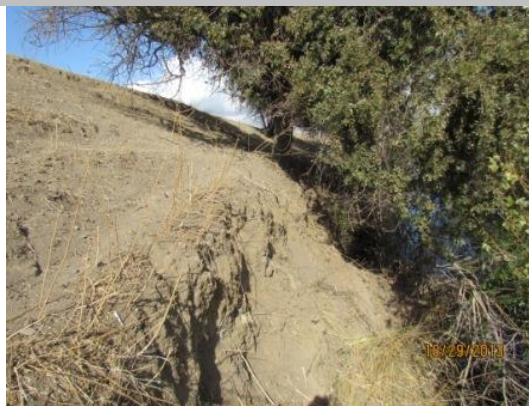
Photo 1 of 3 : SP_2019_RD2058_111_15_20190313_00007.jpg

LM Start	4.76	Rating **	A/W	Issue No.	15
LM End	4.83	Issue Type +	Ma	Location *	WS
Category	Earthen Levee			GPS Latitude/Longitude	
				Start	End
Item	Erosion / Bank Caving			37.785965 °	37.785045 °
				-121.350374 °	-121.349936 °
DWR ID	DWR_RD2058_01_f_2013_15				
Comment Code					
E1 : Note and monitor erosion site.					
Inspector Comment					
The erosion has about a 3 foot vertical cut at the waterside levee toe.

View of the erosion at the waterside levee toe.

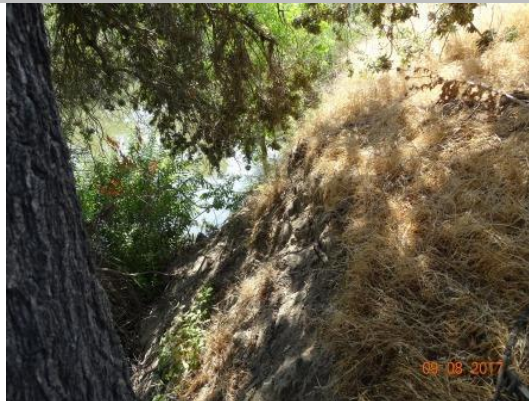
Photo 2 of 3 : SP_2019_RD2058_111_15_20190313_00008.jpg

Upstream view of the erosion.

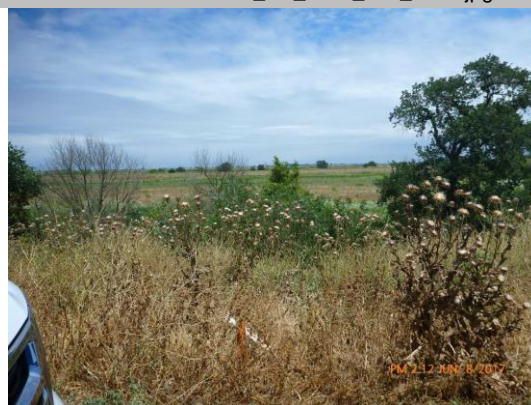
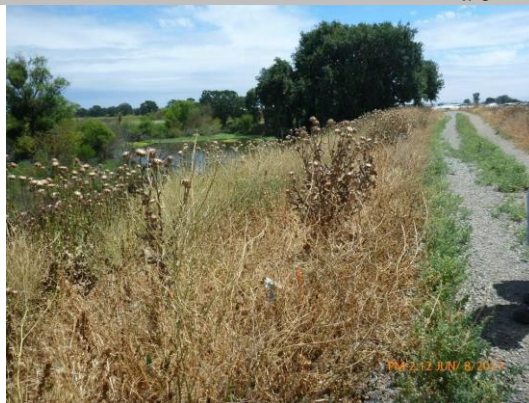
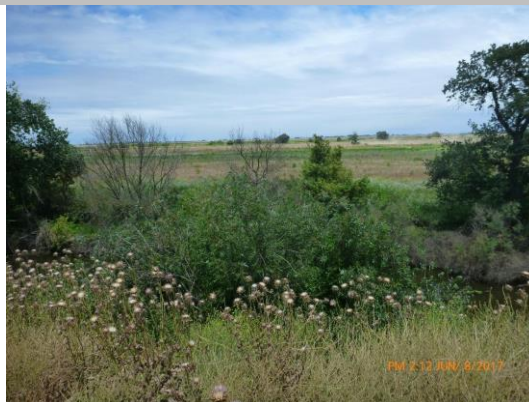
LM Start	4.77	Rating **	A/W	Issue No.	44
LM End		Issue Type +	Ma	Location *	
Category	Supplemental			GPS Latitude/Longitude	
				Start	End
Item	2017 Storm Damage			37.785862 °	°
				-121.350303 °	°
DWR ID	DWR_RD2058_01_f_2017_44				
Comment Code					
Inspector Comment					
Levee Evaluation Comments					
Description:					
Site ID No:100					
Site Designation:FSRP-14-25					
Repair Type: Erosion					
Rating:Area of Concern					
Field Date:6/8/2017					
Notes: vegetation too dense to evaluate damage. The erosion has about a 3 foot vertical cut at the waterside levee toe as of the Fall 2017 Inspection. Turned back over to Evaluators for re-assessment.

LM Start	4.77	Rating **	A/W	Issue No.	44 (cont)	
LM End		Issue Type +	Ma	Location *		
Category	Supplemental			GPS Latitude/Longitude		
				Start	End	
Item	2017 Storm Damage			37.785862 °	°	
				-121.350303 °	°	
DWR ID	DWR_RD2058_01_f_2017_44					
Comment Code						
Inspector Comment						
Levee Evaluation Comments						
Description:						
Site ID No:100						
Site Designation:FSRP-14-25						
Repair Type: Erosion						
Rating:Area of Concern						
Field Date:6/8/2017						
Notes: vegetation too dense to evaluate damage. The erosion has about a 3 foot vertical cut at the waterside levee toe as of the Fall 2017 Inspection. Turned back over to Evaluators for re-assessment.

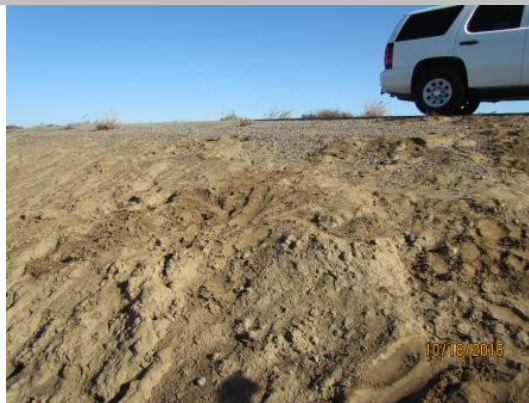
Photo 1 of 1 : SP_2019_RD2058_111_28_20190313_00013.jpg

View of the rodent holes on the levee slope.
